Security Improvements for Oakridge HOA Pool

Prepared 7/3/2019

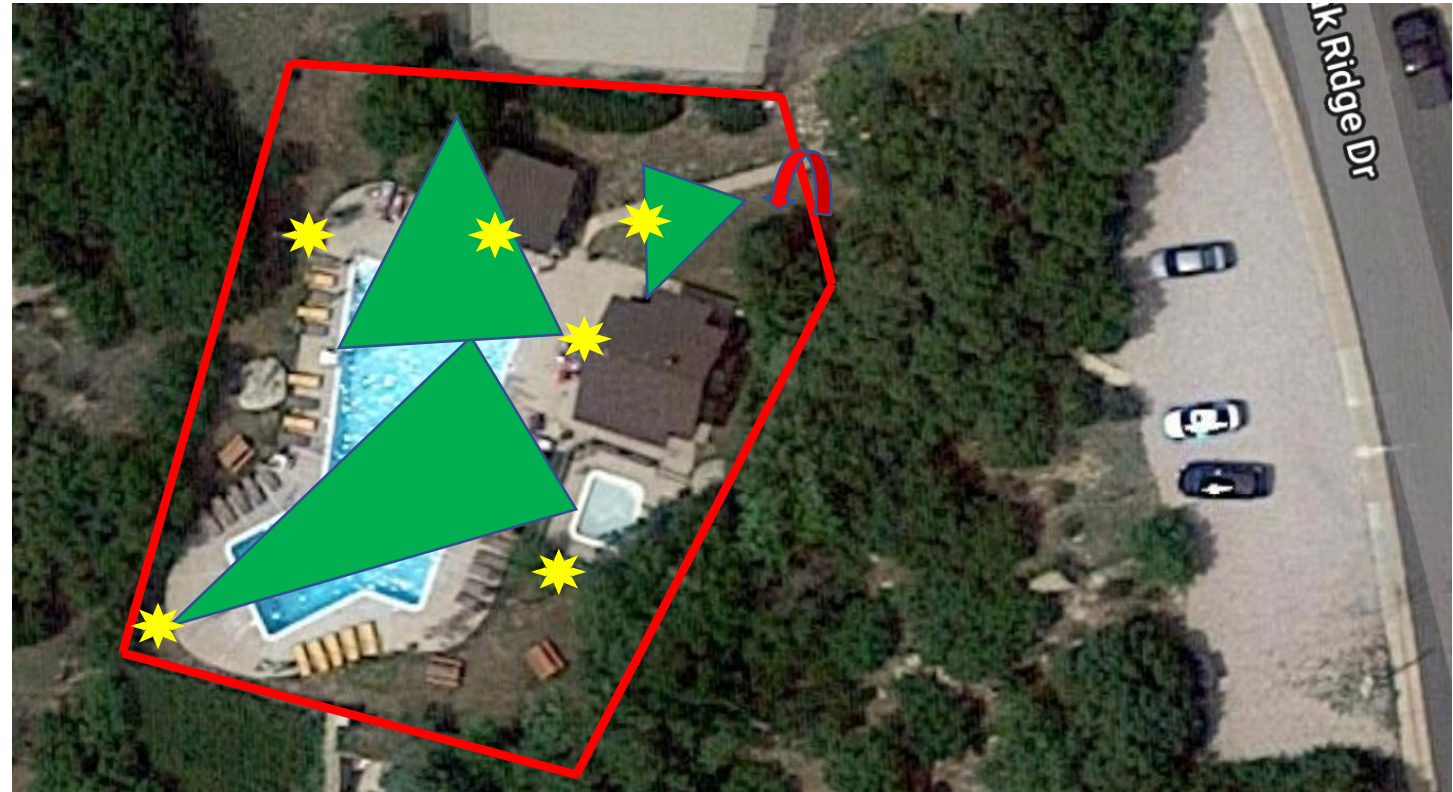
Existing design

- Three webcams (green) provide sufficient coverage during the day but night coverage is poor
- Physical barrier (red) generally sufficient
- Intrusions typically at primary admission gate
- **Lighting (yellow suns) insufficient for existing webcams/security**

- Assumptions
 - Security will not be provided for Multi-sport court
- Core problem
 - Nighttime intrusions have resulted in vandalism that cannot be tracked to individuals (because existing webcams do not function is existing night lighting)
 - Existing night lighting is insufficient along path to get to pool
- Proposed solution
 - Does not prevent intrusions but will capture color night-vision video sufficient for police review
 - Focused on high-value targets (e.g. guardshack, bathrooms)
 - Supports future decision reducing number of lifeguards

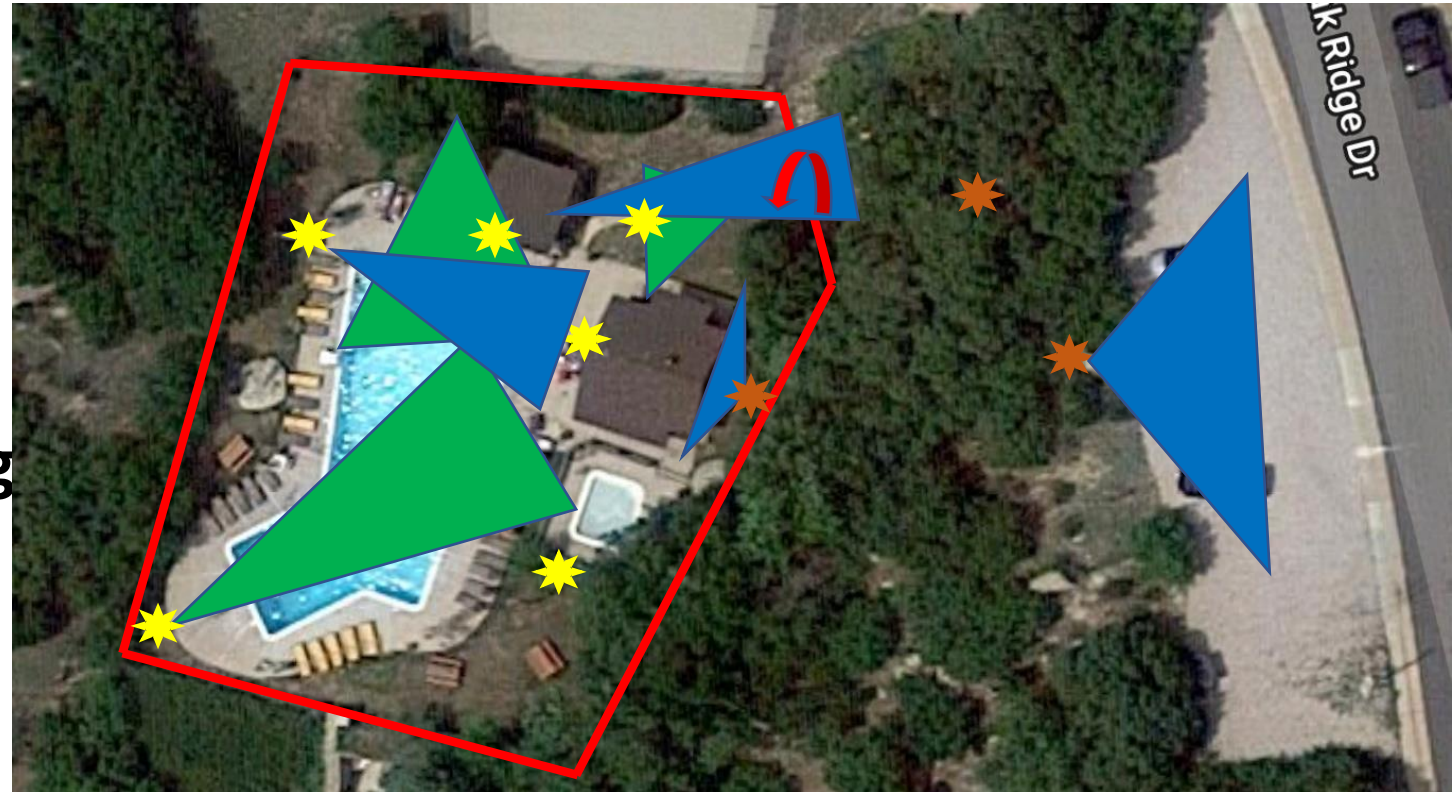
Proposed design (highlighting changes)

- Additional 4 webcams (blue) provide sufficient coverage during the day and night
- All webcams are color, night-vision (infrared)
- Additional security lighting (orange suns)
- Video surveillance integrated into HOA website

One additional webcam will be kept as spare

- Security System \$1349.99
 - (4K Ultra HD IP NVR System with 8 Outdoor 4K 8MP IP Cameras, 200ft Night Vision)
- Security System Installation HOA task
- New Lighting
 - Poles for lights x 3 TBD
 - Lights x 3 TBD
 - Electrical hookup x 3 TBD
- Wiring for new camera TBD
- Integrate surveillance into website HOA task
- Taxes TBD
